### 3 Coulton Building Characterisation and Analysis

## Condition Survey and Recommendations for Repair.

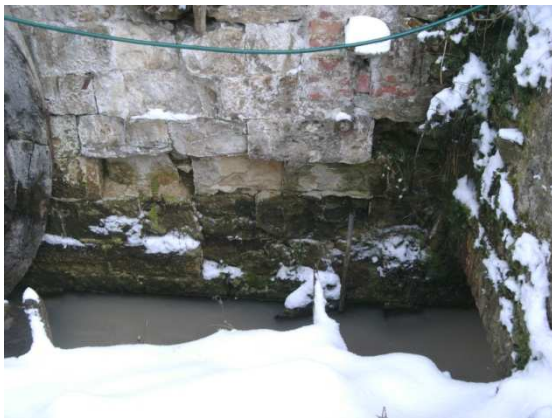
*high status ashlar of lower mill-house wall (left), much frost-damaged. Higher status sandstone to right of doorway of mill-house (below).*

The condition of the masonry of most of the mill-house is good. The ashlar stonework of the lower tail-race wall has suffered extensive frost damage, with faces spalled away to some depth. Some introduction of new facing stone, dressed as originally, will be necessary. A section of wall behind the mill-wheel has fallen out entirely and will require like for like reinstatement. The inner wythe of masonry within the lay-shaft pit is of brick and may represent repairwork at this level in the past. The single skin of brick is all that currently supports the masonry above the hole in the wall. All repair mortar at this level will be Natural Hydraulic Lime 3.5 due to the inherent wetness of the location. The same will be used for some localised mortar repairs of less deeply eroded blocks.

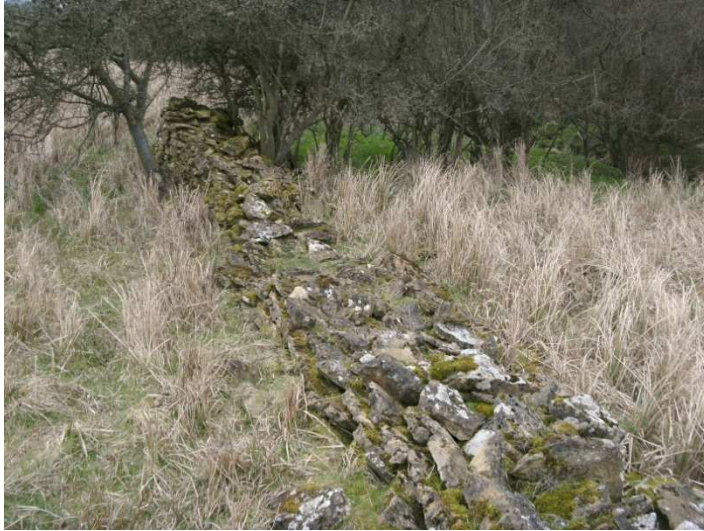
*dry-stone wall of the former 'fold-yard'.*

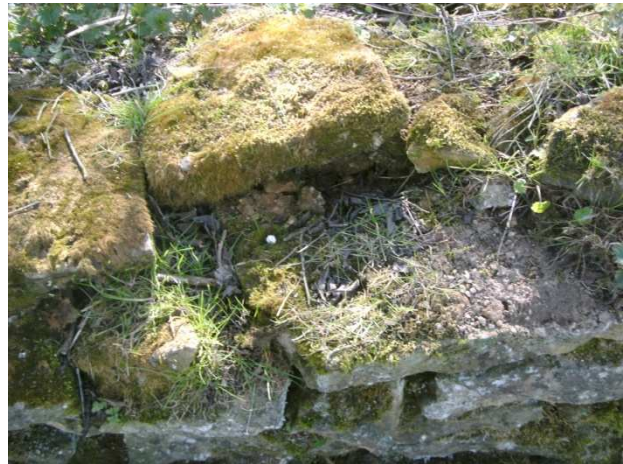
*Earth and quicklime mortar, upper cart-shed wall, built in the second half of the 19thC*

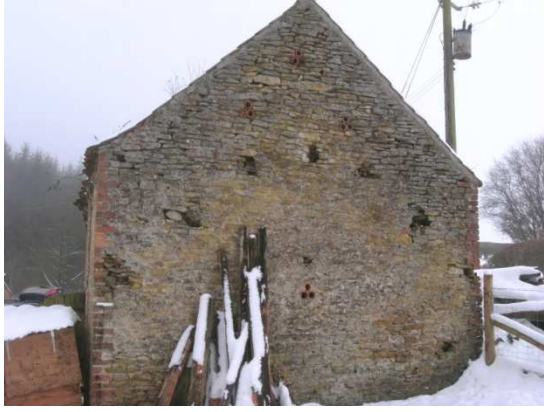
*north and south walls of the cow byre*

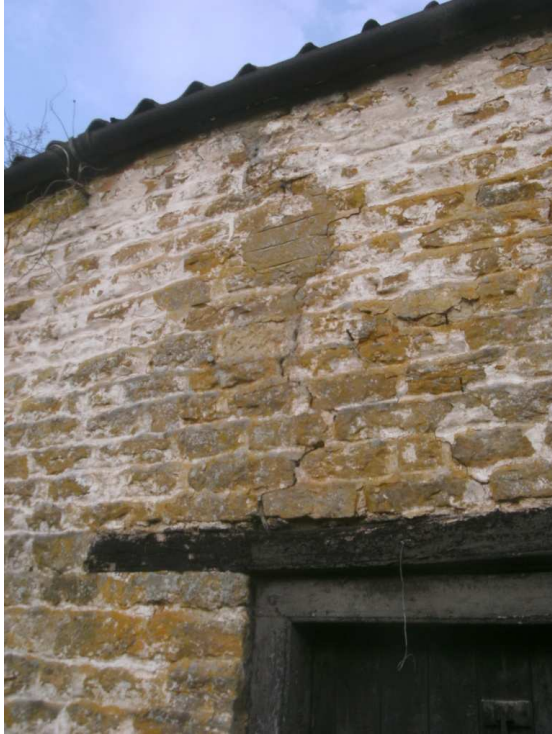
*remnant limewash, mill-house*

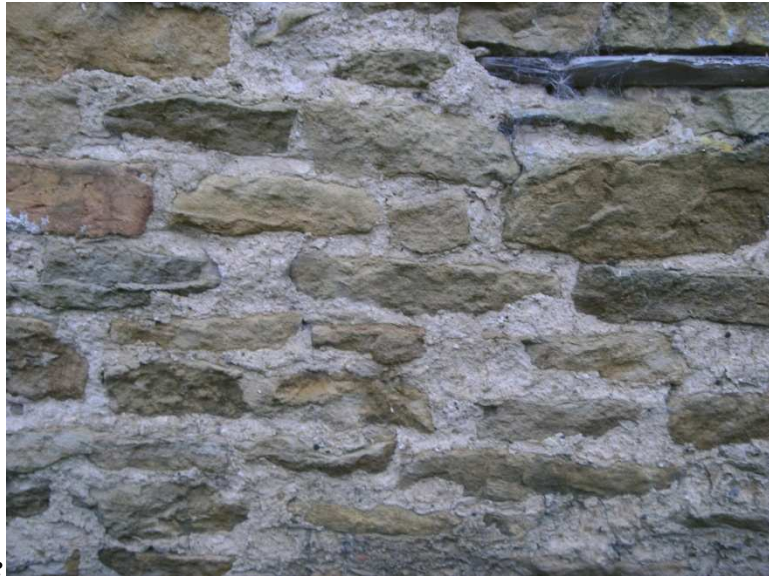
*lime pointing, cow byre*

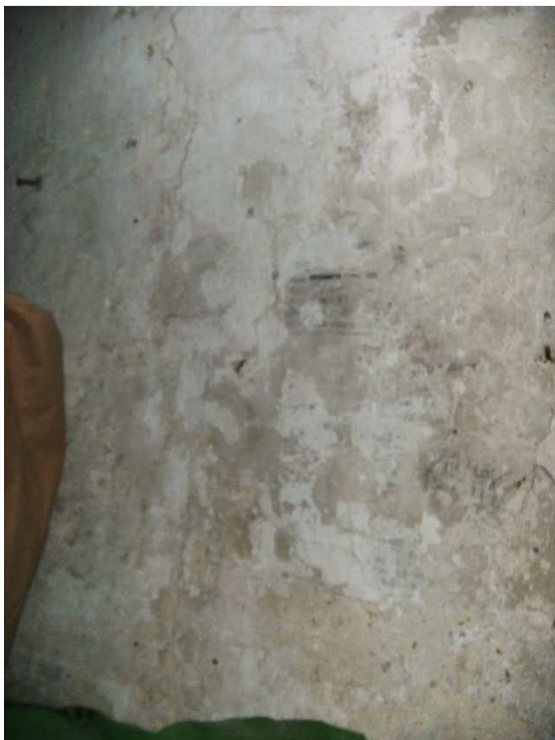
*lime plaster (with pencil lists) mill-house*

There are several cracks to the E and S wall plaster and these should be filled. Approx 2 metres squared of replastering is required to the N wall. There are a number of pencil-written notes upon the surface of the limewashed plaster of this wall and it will be essential that this is preserved.

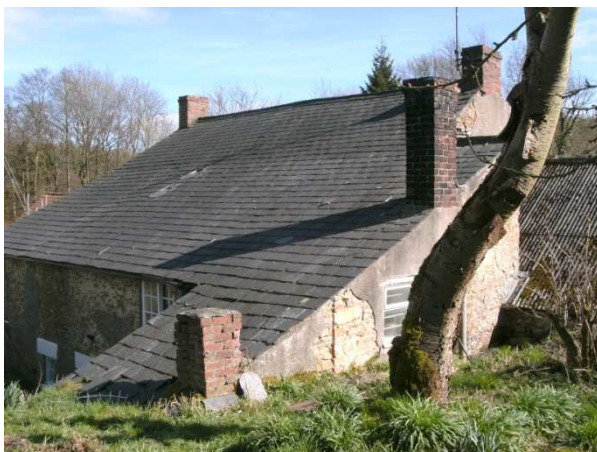
*back, cat-slide roof of the house, some remnants of opc render*

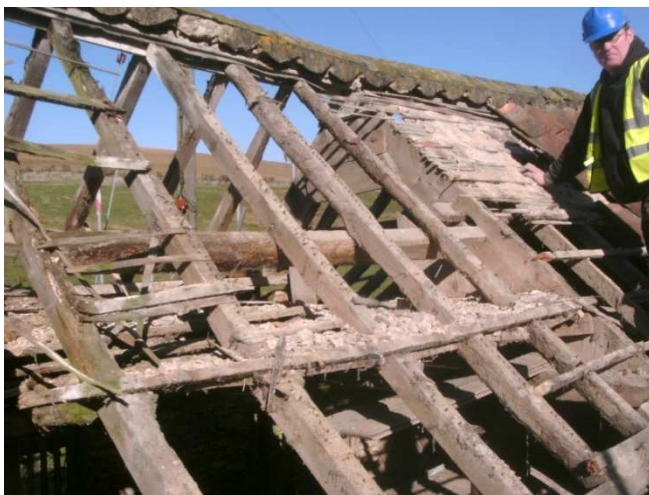
*roof of the cow byre during emergency repair*

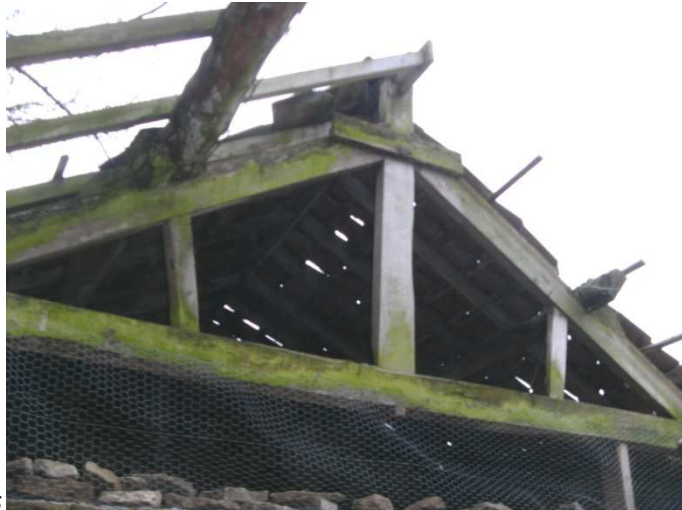
*truss over single storey loose-boxes*

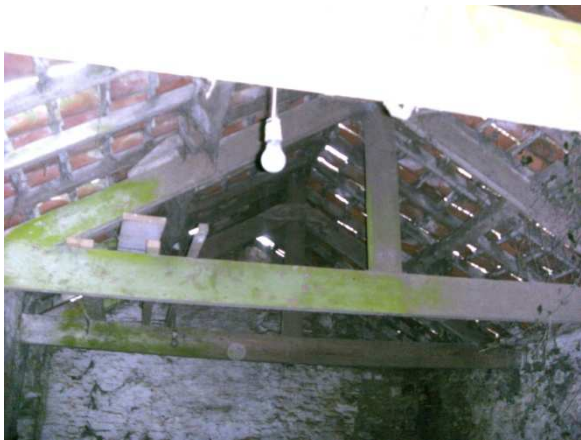
*simple king-post trusses, single storey cow-shed*

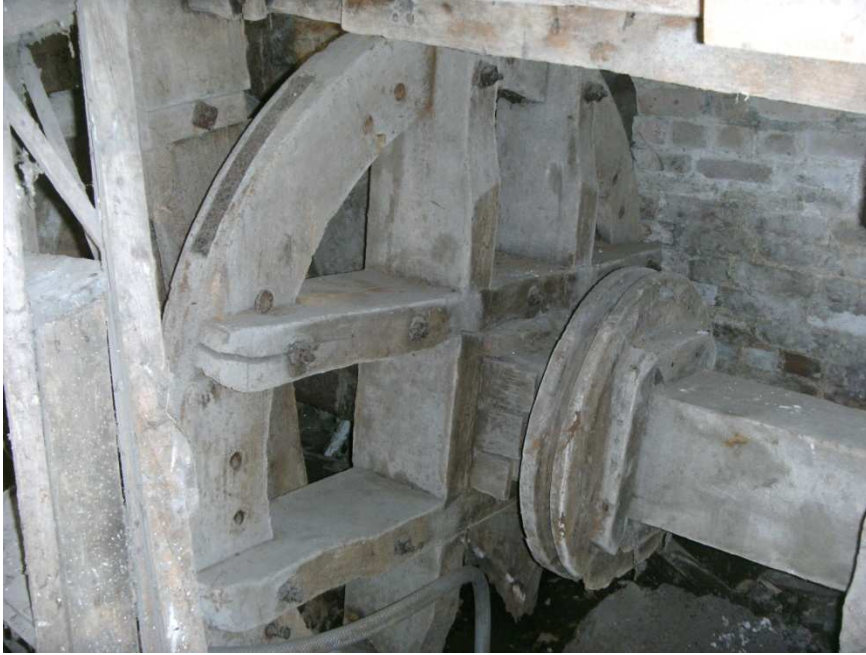
*within- note the liberal use of coach-bolts, which may be interpreted as having been introduced during 20thC repairs.*

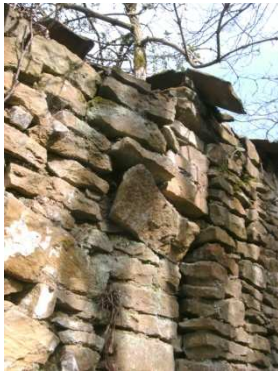
There is approx 1 metre square of severely deflected stonework at high level and the N end of the larger cow-shed – the stone facing is being levered outwards by the roots of an elder tree.
