Crambe St Michaels Chancel

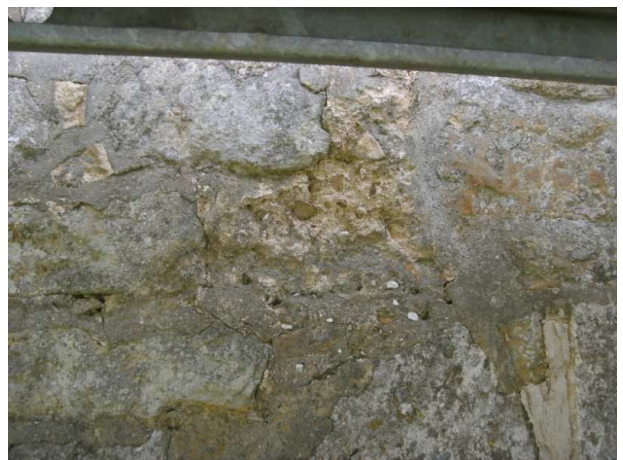
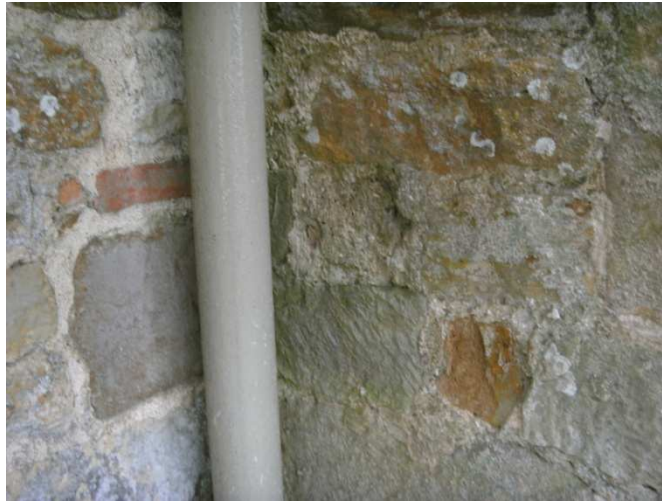
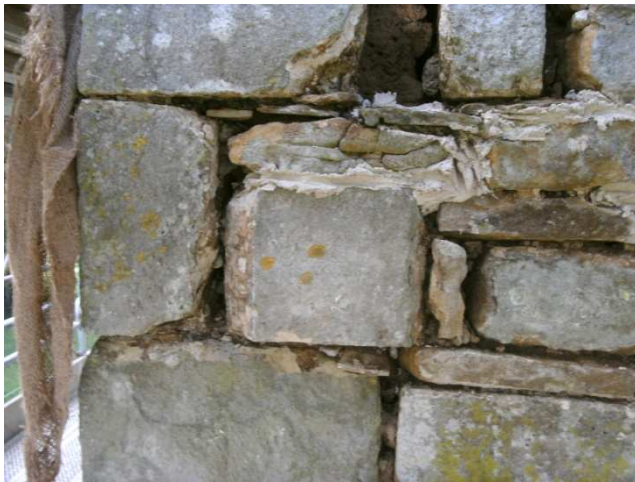
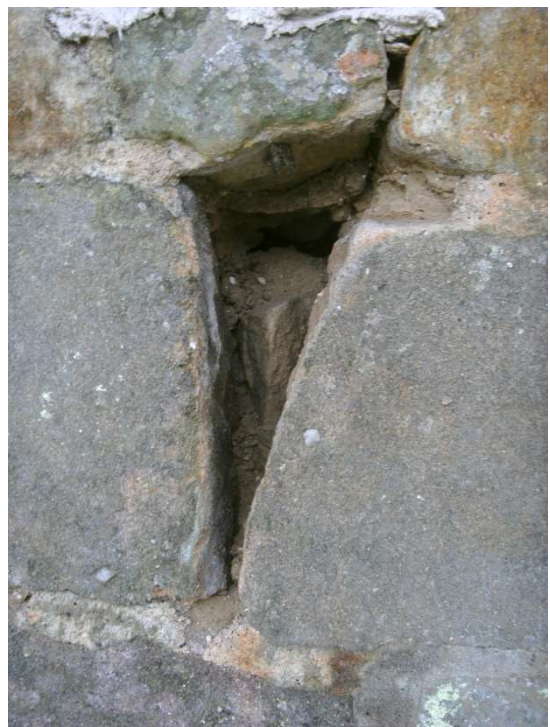
Historic lime mortar repairs, N wall (right) and W wall of Nave (below

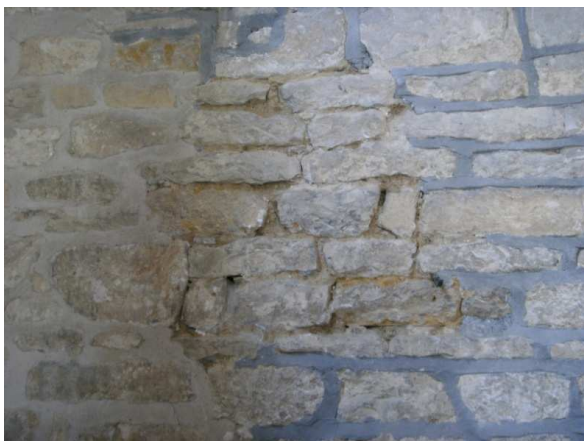
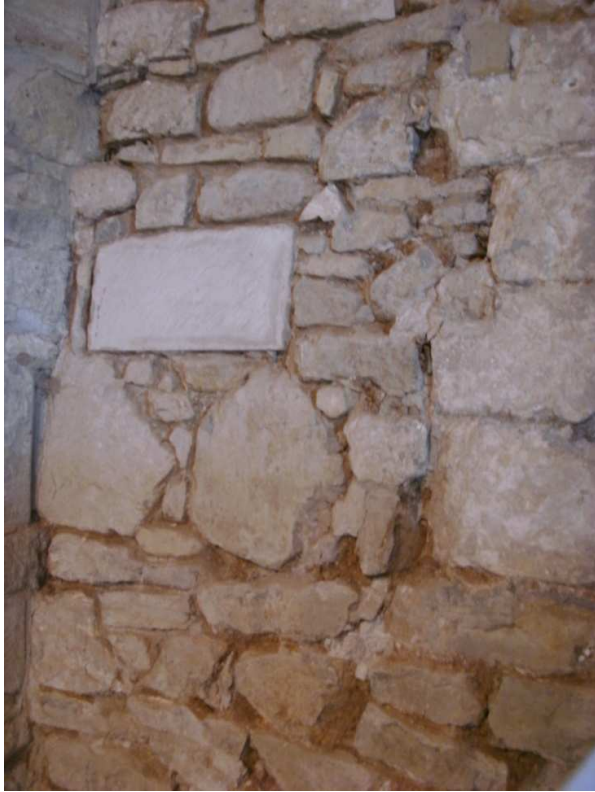
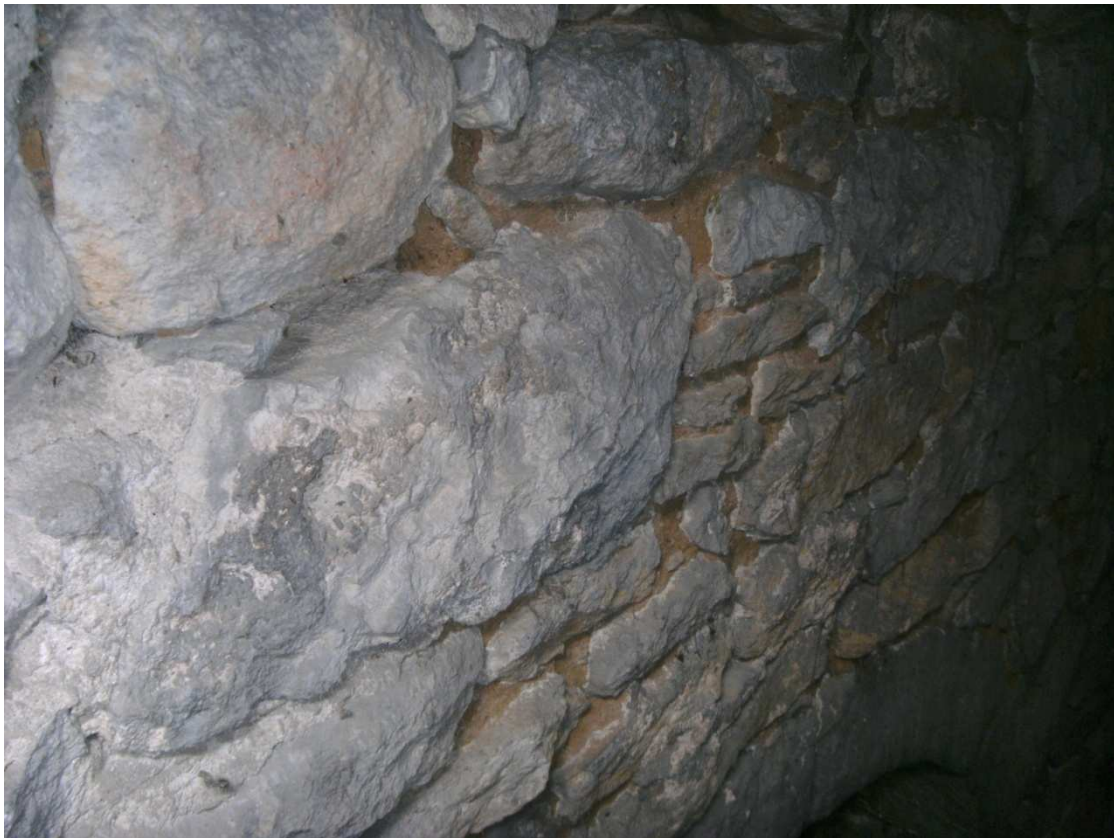
Earth mortars to the wall core, N wall of Chancel (above) and, internally, to S and E walls (below)

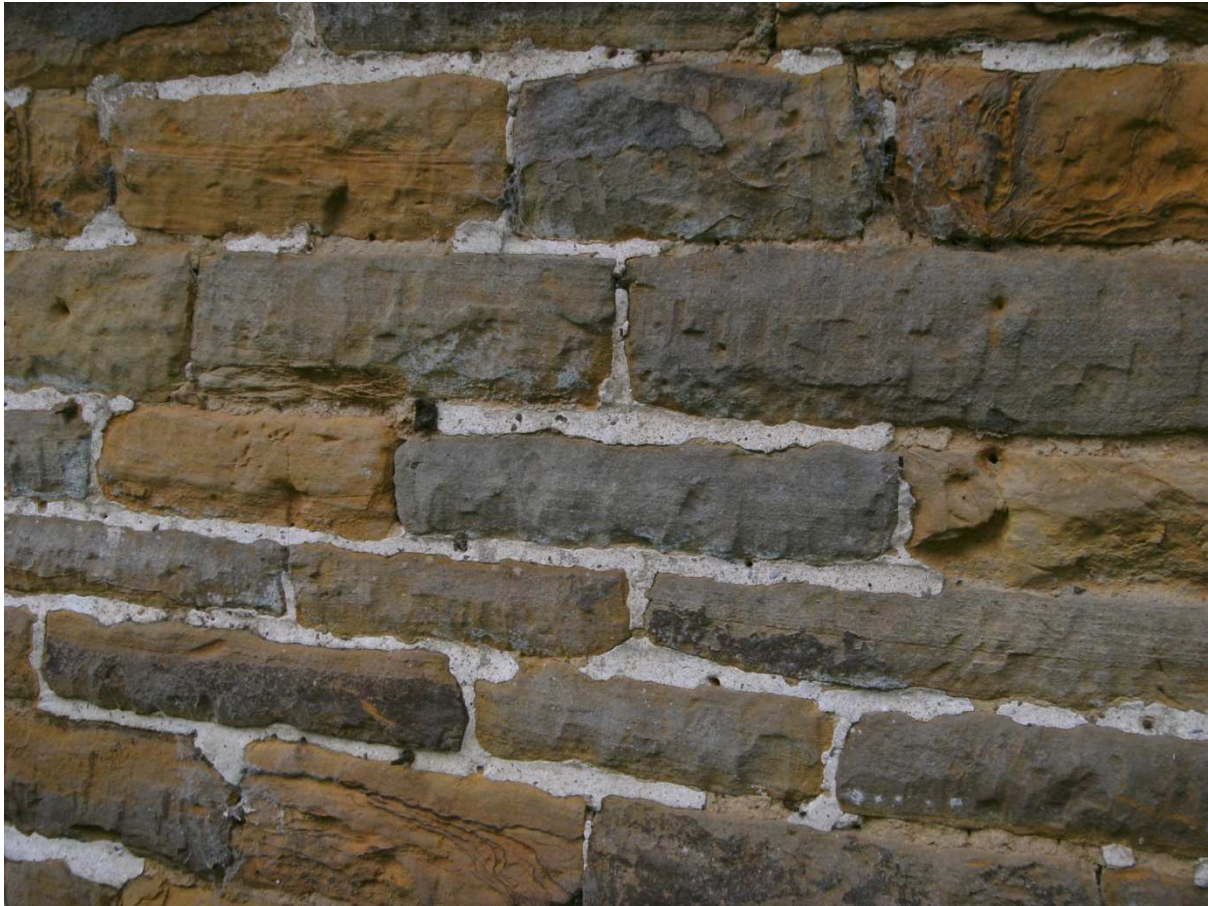
Earth mortar within tower(above) and same, with original lime pointing, Pond Farmhouse

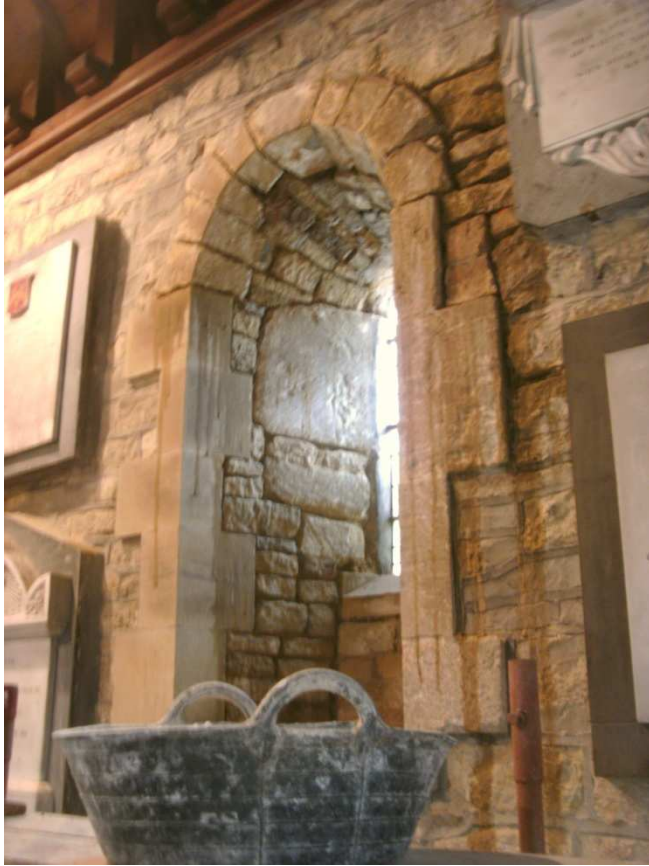
The reveals of all windows of the chancel had been repointed in the past with an almost neat opc mortar. This was removed and all were repointed with the interior lime mortar mix (see above). The masonry around the earliest NW window was repointed also, the opc repointing being loose.

NW window after removal of opc pointing

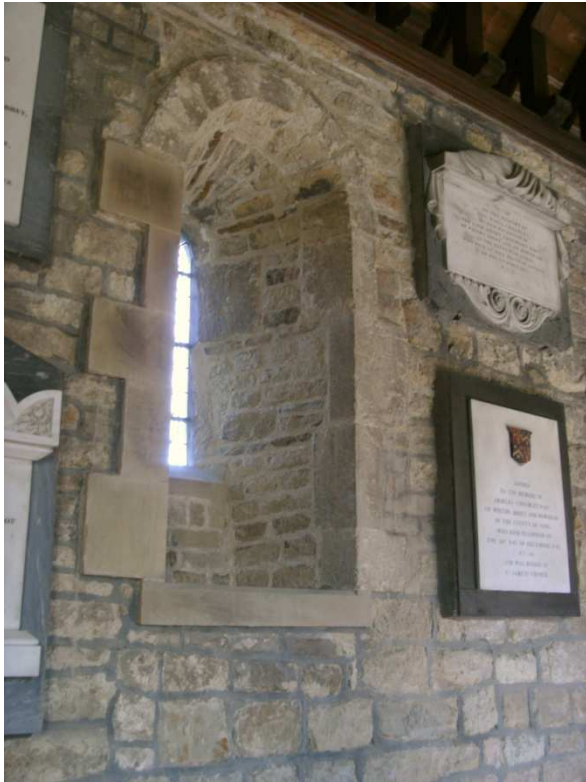
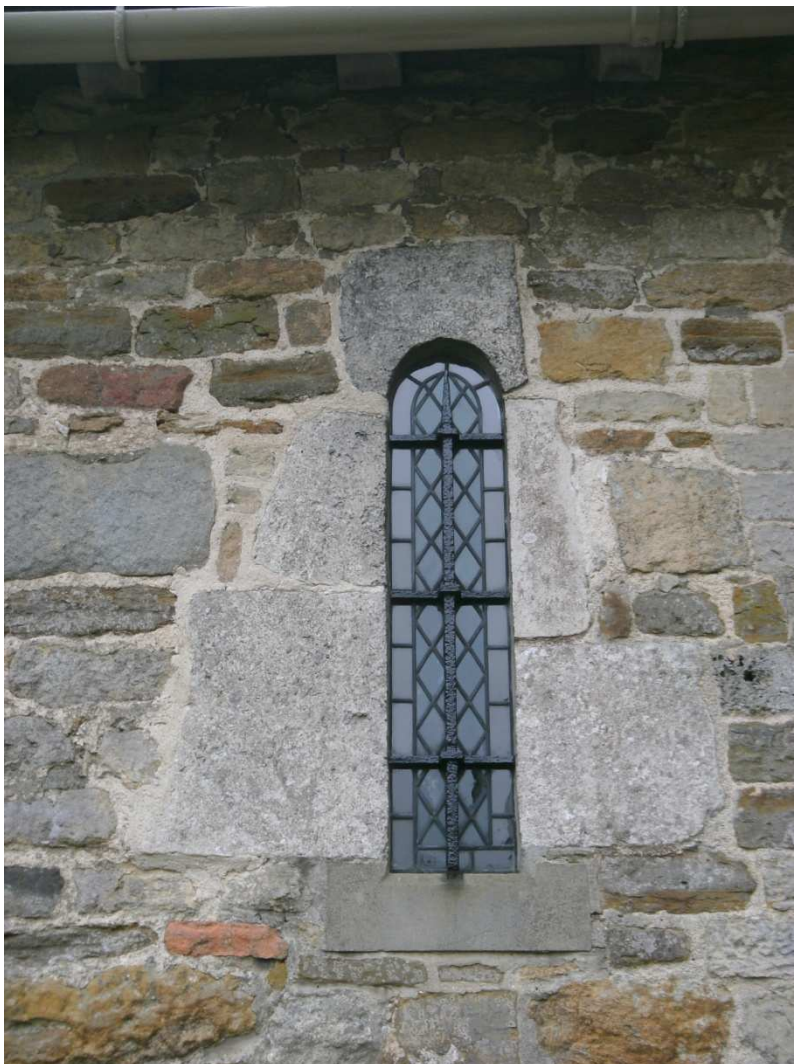
exterior view of same. The jambs and heads are of Hildenley limestone. Joints immediately adjacent were relieved of hard and loosening opc mortar and repointed with lime mortar.

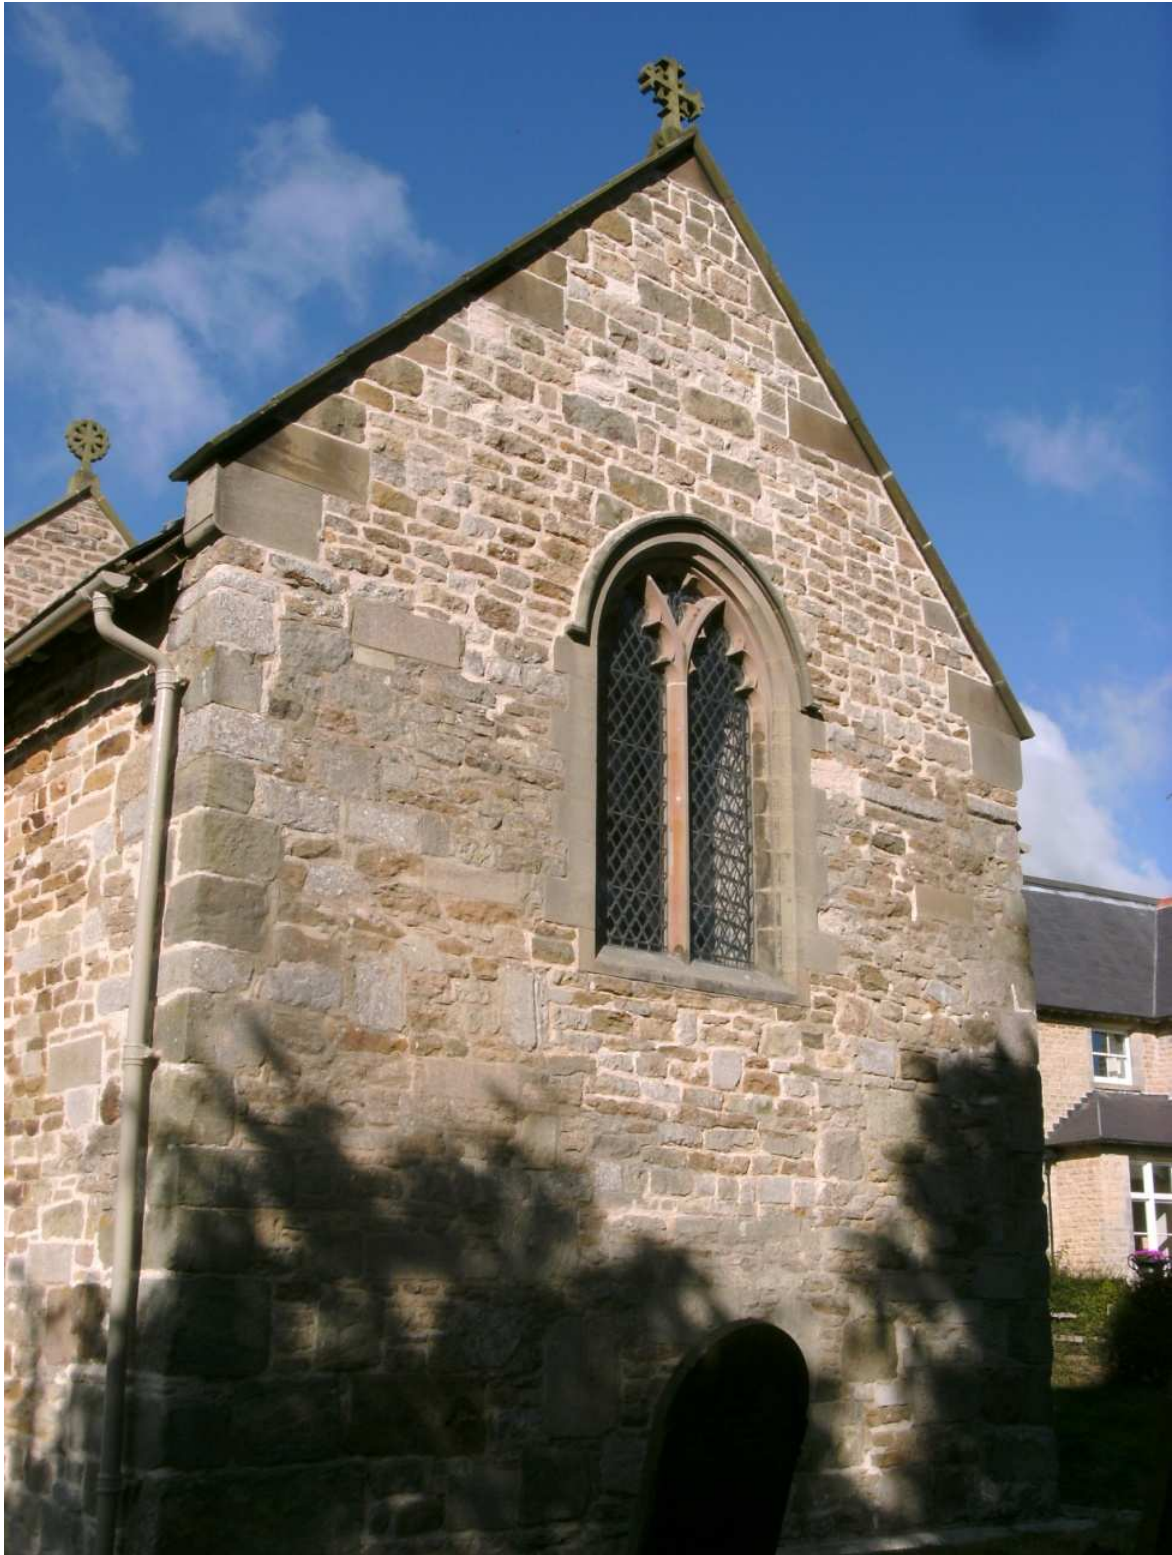
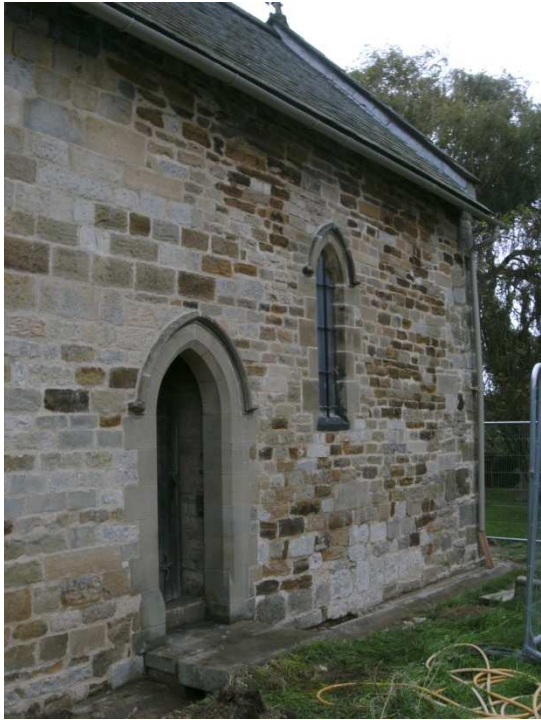
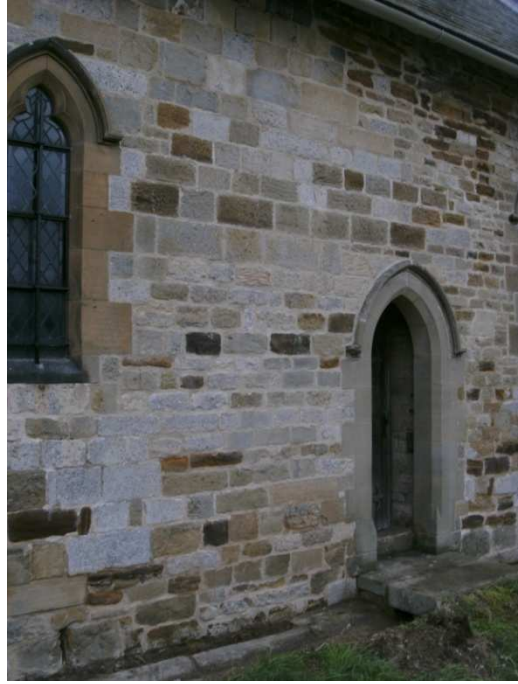
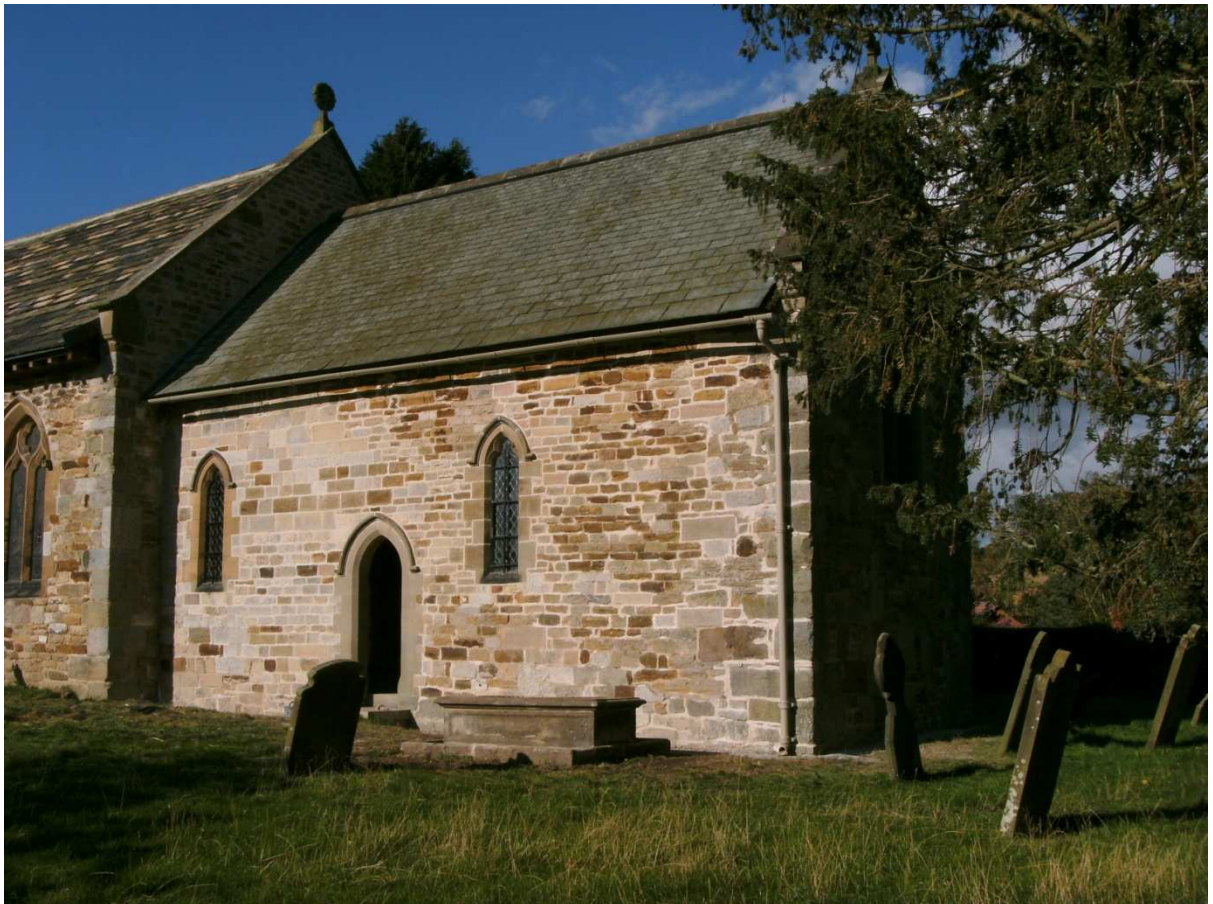
The S wall of the chancel was repointed about 80%, more than originally intended. Opc pointing that had seemed sound upon inspection and at the time of pricing, had come loose since – perhaps as a result of the thermal stresses set up by the exceptionally cold and prolonged winter of 2010/11. Fine joints to the pennine sandstone windows were also repointed, with a weakly NHL mortar and ‘silver sand’ mortar.

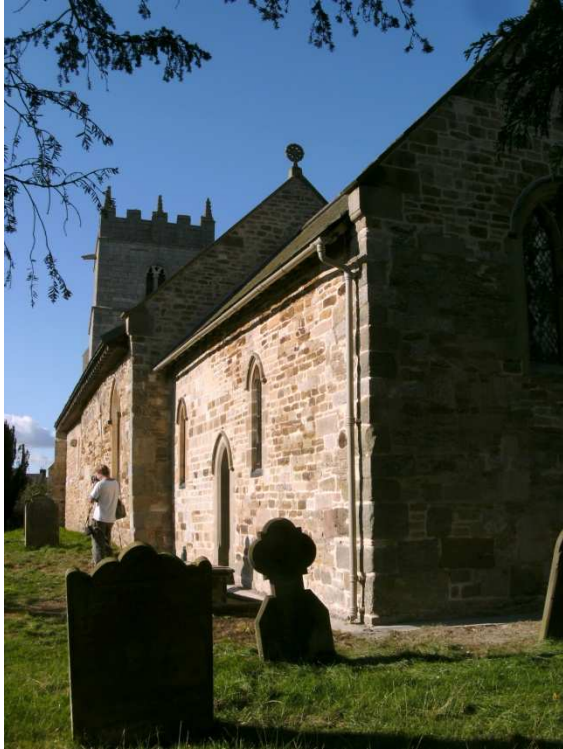
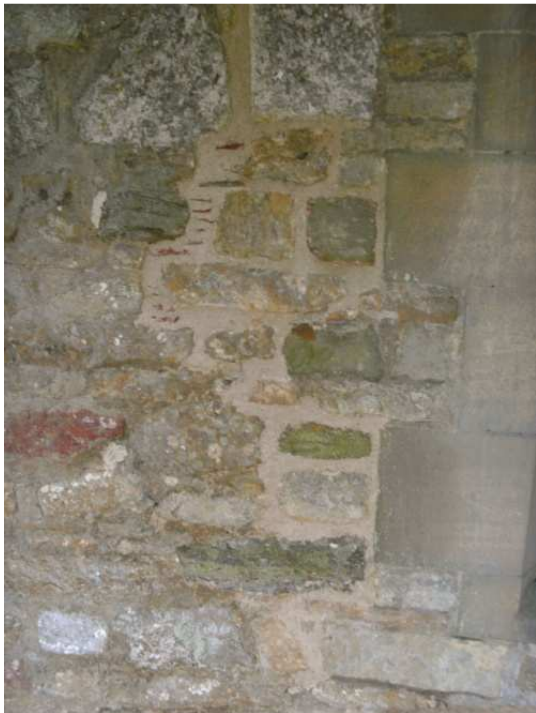
Repointing to the N wall was much less extensively required, consistent with its thermal stability. Much of the earlier lime mortar to this elevation remains intact with only localised intervention with opc in the past. There were some significant movement cracks, which were packed with lime mortar and small sections of clay plain tile.

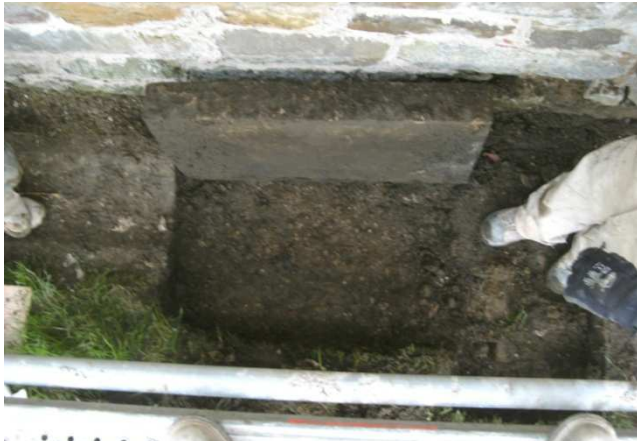
It had been originally intended to remove a stone channel at the base of the walls. In the past, the nave had a gutter which discharged into a section of concrete channel at its E end which fed into the stone channel. The stone channel is of Jurassic sandstone. Investigations established that this channel rested above a projecting stone footing for the wall – at least on the N side, where excavation was carried out near the junction of the chancel wall with the nave. The two channel stones lifted were bedded upon naturally occurring boulder clay and a scattering of broken clay pipes, remnants of an earlier drainage scheme. Excavation at the base of an in situ channel stone to the E side showed this to have been bedded upon a (probably hydraulic) lime mortar. The presence of the stone footing made it impossible to install a French drain and it was decided to leave the stone channel in situ, whilst moving the down-pipes to their earlier location at the E end of the chancel walls and adjusting the fall of the gutters. Their earlier relocation to the W end of the nave had led to an accumulation of moisture at the base of the walls in the vicinity of the down-pipes. It is anticipated that this excessive moisture will now decline. The base of the walls generally is not damp and the floor of the chancel is somewhat higher than ground level. A hard opc fillet between stone channel and the wall was broken out and the void back-filled with 20mm shingle to enhance vapour permeability at the wall foot. The earlier cementitious fillet was left to the E wall, it being very narrow and its removal being very likely to cause damage to the stone channel.

view on lifting channel stone, N side

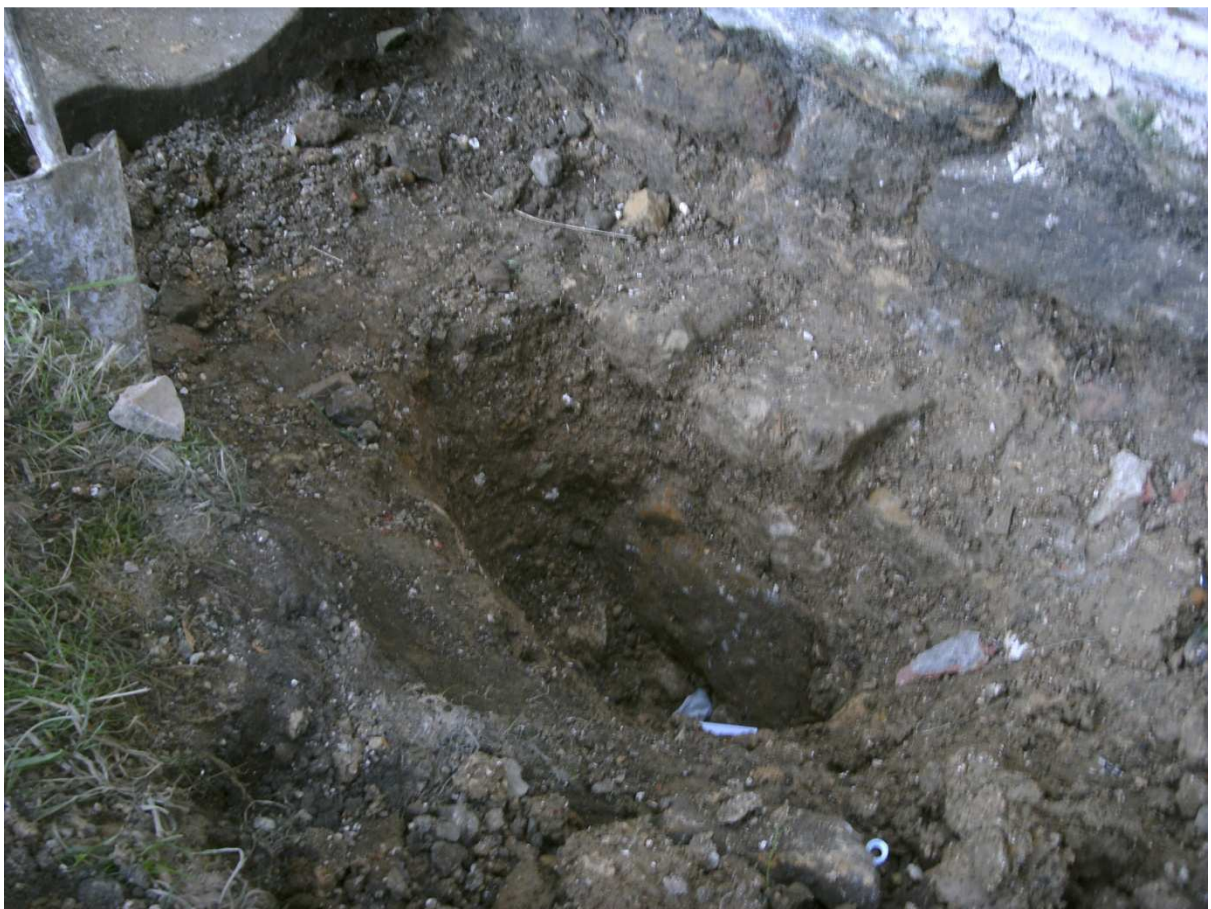
Stone footing of N channel wall beneath this channel stone

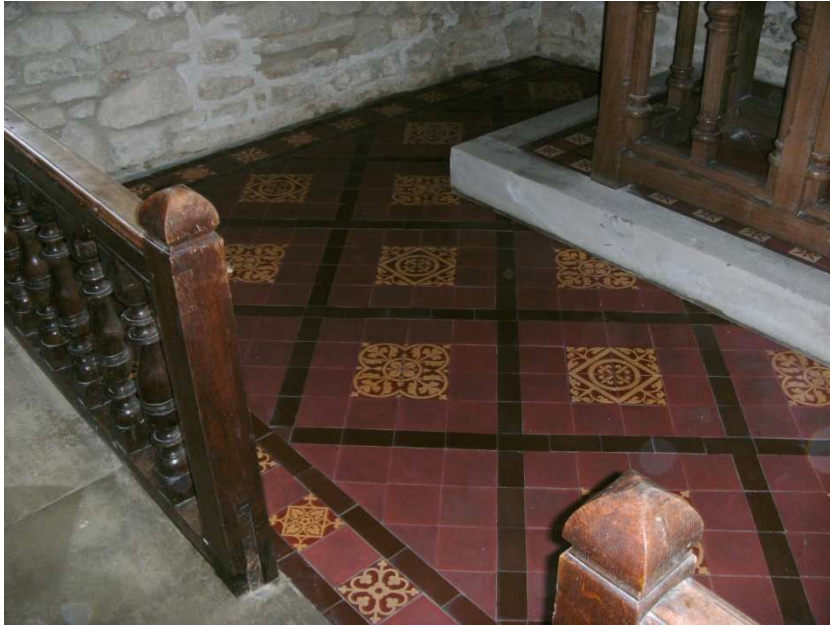
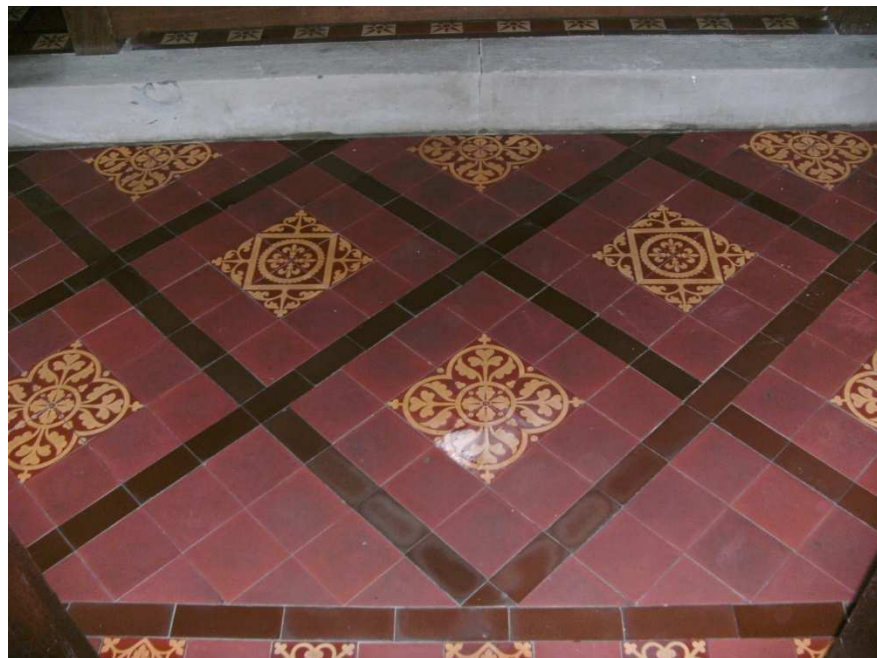
The floor of the chancel is of encaustic and geometric tile laid around pre-existing grave-slabs. Some eight geometric tiles require replacement – 6 plain red and two brown glazed. The floor was cleaned using Vulpex detergent/degreaser diluted at 1: 10 and cleaning was carried out by hand using cotton cloths. The Vulpex began to break down waxes in places where these were quite thickly applied. Vulpex is supplied by Picreator UK.

Replacement of required new tiles is yet to be carried out, but it is anticipated that the tiles will be laid upon lime mortar and that, remnant floor waxes notwithstanding, this floor enjoys appropriate breathability. It will be important that such vapour permeability is retained in the future – the application of non-breathable finishes in the past may be witnessed upon several of the grave-slabs, as may be the decay that such finishes have promoted in these stones. The new tiles will be supplied by Craven Dunhill Jackfield, Ironbridge, Shropshire, the probable manufacturers of the original tiles.
