### 3 Coulton Building Characterisation and Analysis

## Condition Survey and Recommendations for Repair.

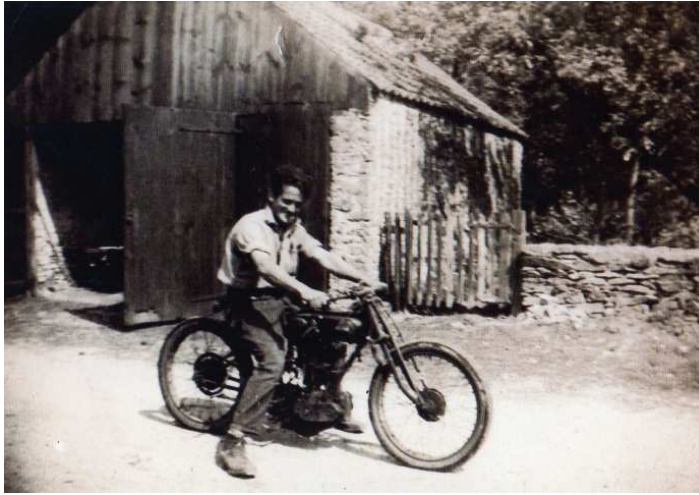
*the cart-shed, then garage, opposite the mill house, circa 1936-8; Thomas Harrison, son of John Thomas, last miller at Coulton and who last repaired the mill wheel. The same below as it is today.*

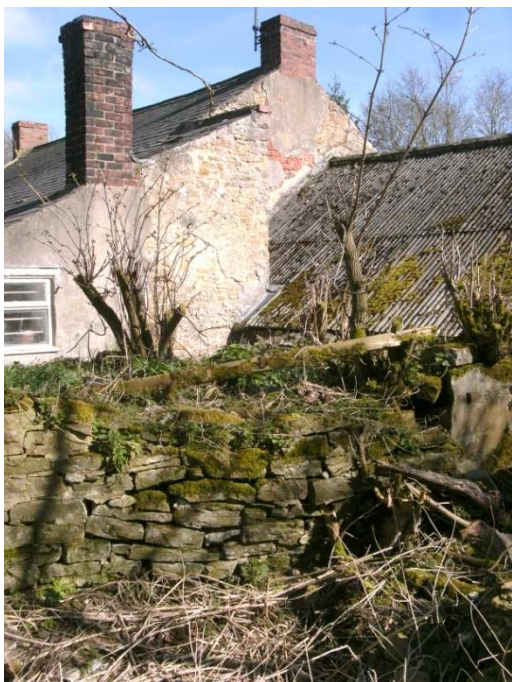
*stone wall of the head-race as it turns to feed the pentrough (left) and tail-race (below).*

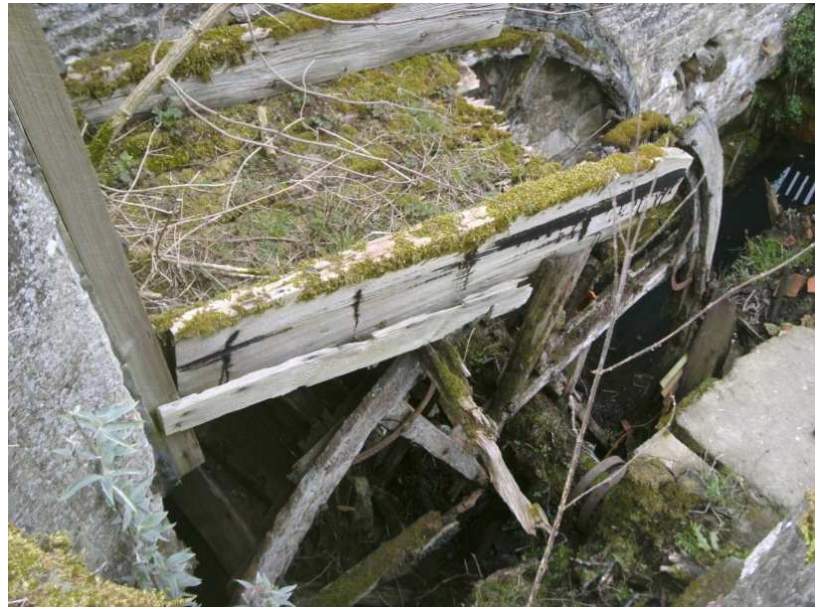
*the trough and wheel, with remnant penstock at left of picture*

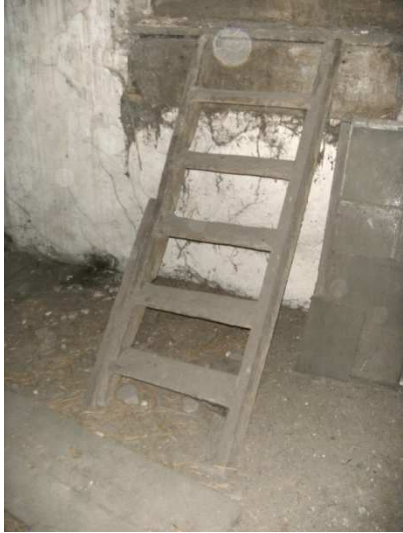
*ladder  
to the above. This doorway and the one within the two-bay attic  
are wide, indicating their storage purpose*

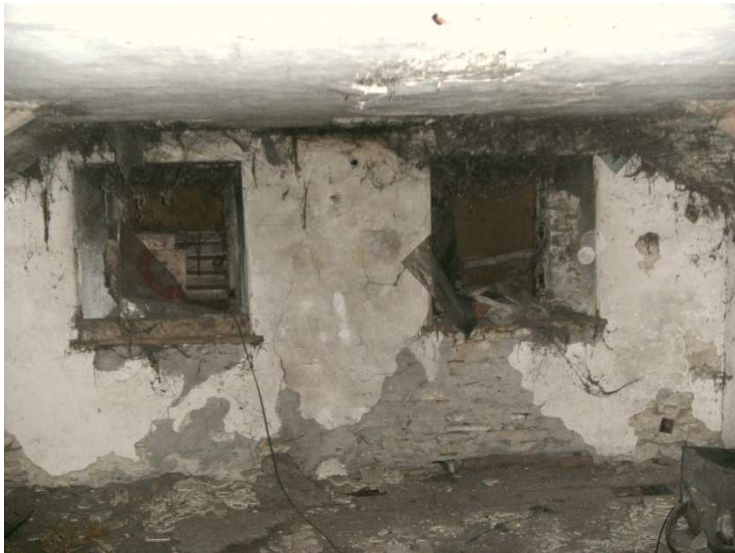
*blocked windows, N end*

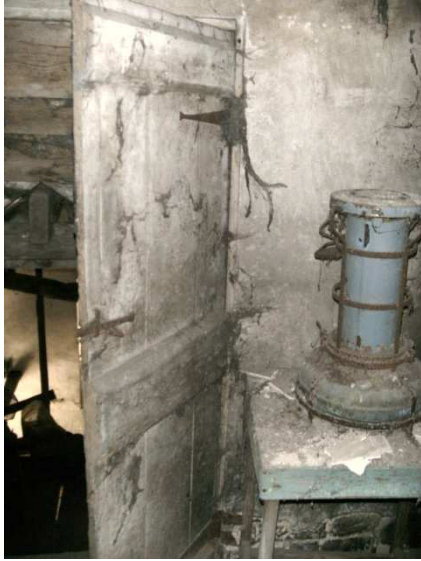
*one of double doors between house and mill-house attics*

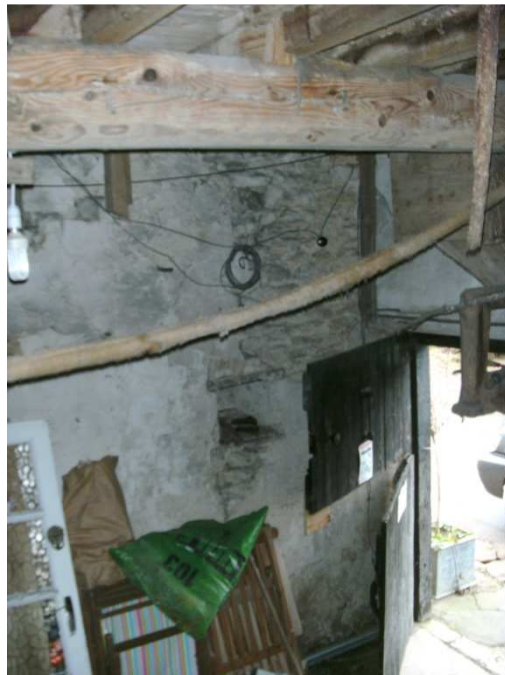
*Inside of mill-house*
