Crambe St Michaels Chancel

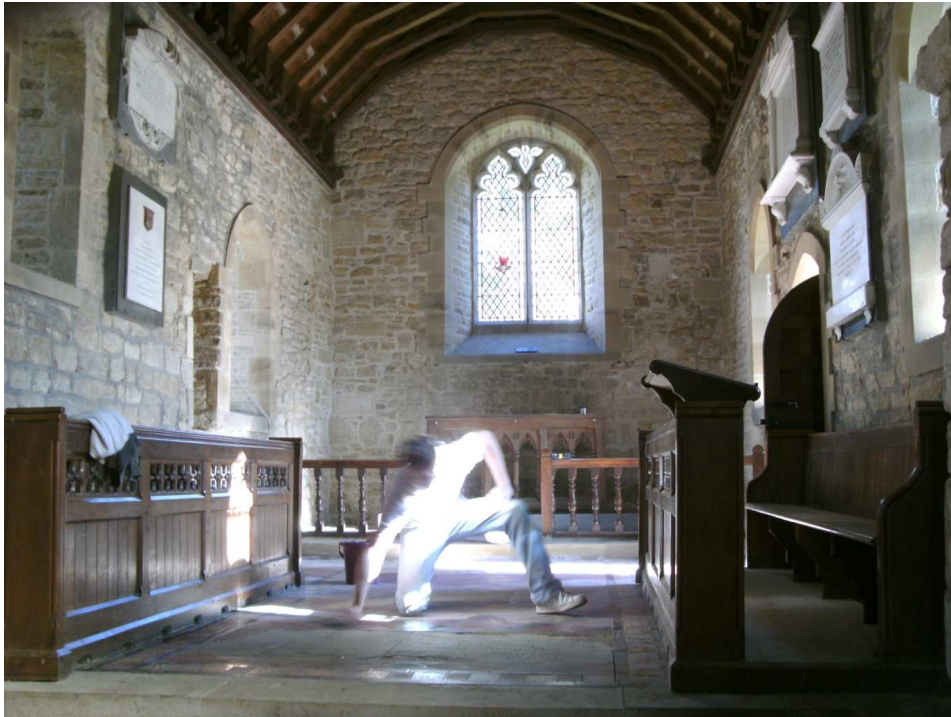
The e end of the chancel was repointed almost 100%, all sound lime mortar joints being left in situ.

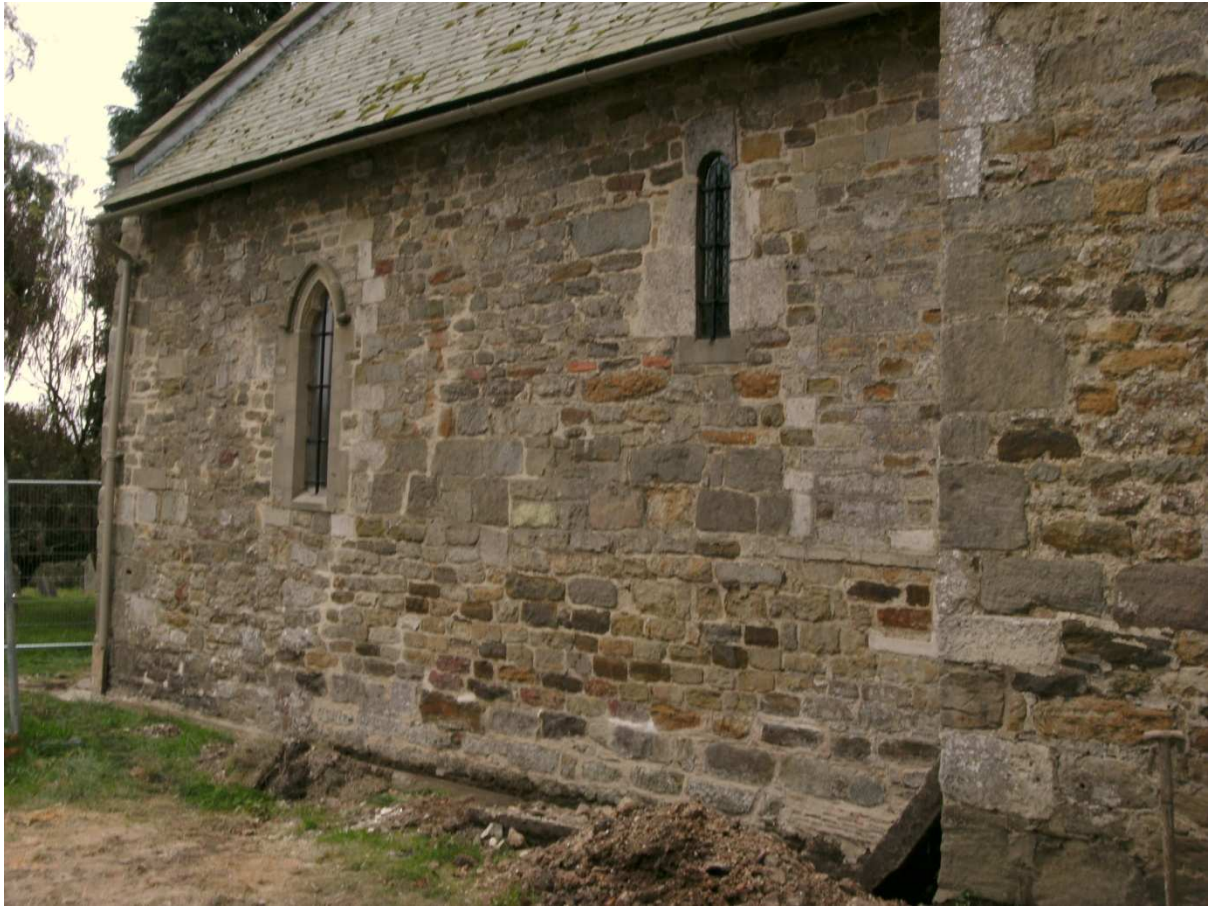
It had been originally intended to remove a stone channel at the base of the walls. In the past, the nave had a gutter which discharged into a section of concrete channel at its E end which fed into the stone channel. The stone channel is of Jurassic sandstone. Investigations established that this channel rested above a projecting stone footing for the wall – at least on the N side, where excavation was carried out near the junction of the chancel wall with the nave. The two channel stones lifted were bedded upon naturally occurring boulder clay and a scattering of broken clay pipes, remnants of an earlier drainage scheme. Excavation at the base of an in situ channel stone to the E side showed this to have been bedded upon a (probably hydraulic) lime mortar. The presence of the stone footing made it impossible to install a French drain and it was decided to leave the stone channel in situ, whilst moving the down-pipes to their earlier location at the E end of the chancel walls and adjusting the fall of the gutters. Their earlier relocation to the W end of the nave had led to an accumulation of moisture at the base of the walls in the vicinity of the down-pipes. It is anticipated that this excessive moisture will now decline. The base of the walls generally is not damp and the floor of the chancel is somewhat higher than ground level. A hard opc fillet between stone channel and the wall was broken out and the void back-filled with 20mm shingle to enhance vapour permeability at the wall foot. The earlier cementitious fillet was left to the E wall, it being very narrow and its removal being very likely to cause damage to the stone channel.
