### 3 Coulton Building Characterisation and Analysis

## Condition Survey and Recommendations for Repair.

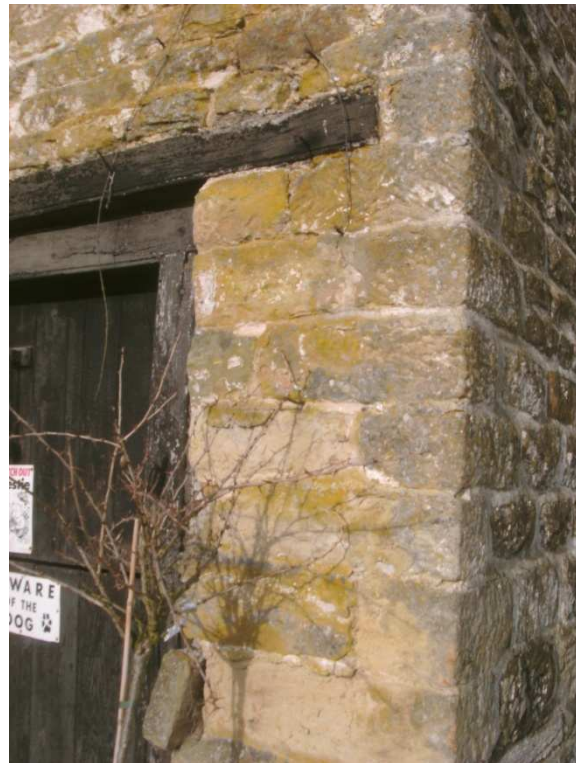
*high status ashlar of lower mill-house wall (left), much frost-damaged. Higher status sandstone to right of doorway of mill-house (below).*

The condition of the masonry of most of the mill-house is good. The ashlar stonework of the lower tail-race wall has suffered extensive frost damage, with faces spalled away to some depth. Some introduction of new facing stone, dressed as originally, will be necessary. A section of wall behind the mill-wheel has fallen out entirely and will require like for like reinstatement. The inner wythe of masonry within the lay-shaft pit is of brick and may represent repairwork at this level in the past. The single skin of brick is all that currently supports the masonry above the hole in the wall. All repair mortar at this level will be Natural Hydraulic Lime 3.5 due to the inherent wetness of the location. The same will be used for some localised mortar repairs of less deeply eroded blocks.

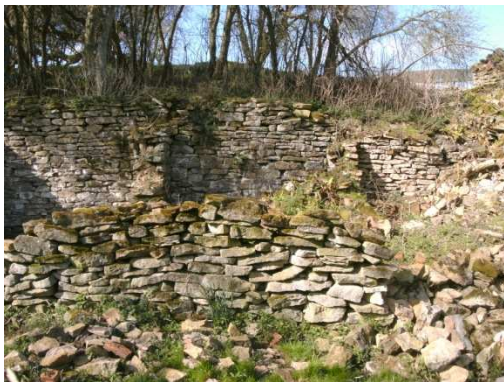
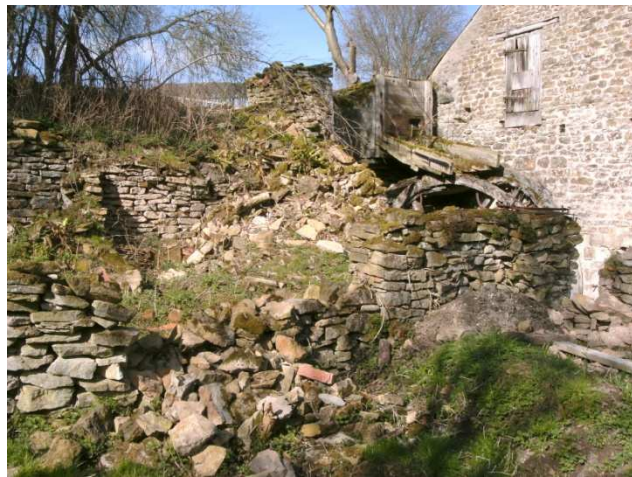
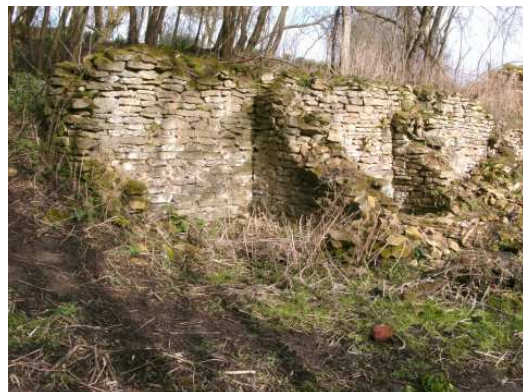
*Remnant pig-sties (below) forge and S wall of mill wheel building (right).*

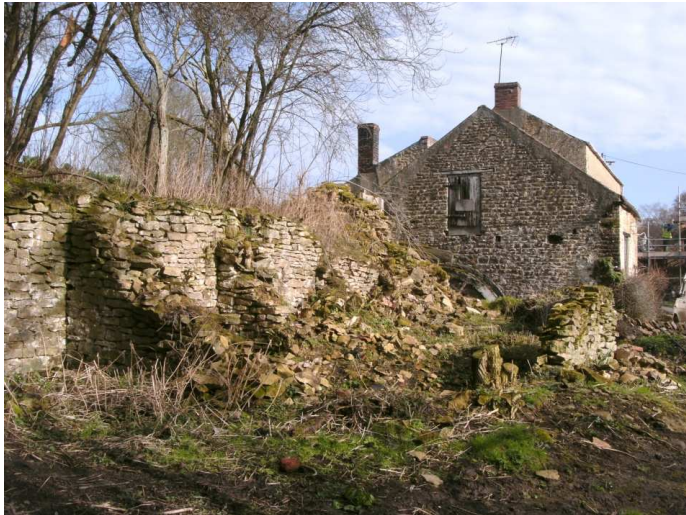
*Pig-sties built perhaps during the 19thC against the much older retaining wall of the head-race, which may – along with the mill-dam itself and the lower levels of the mill-house – be among the earliest (and very early) structures on the site.*

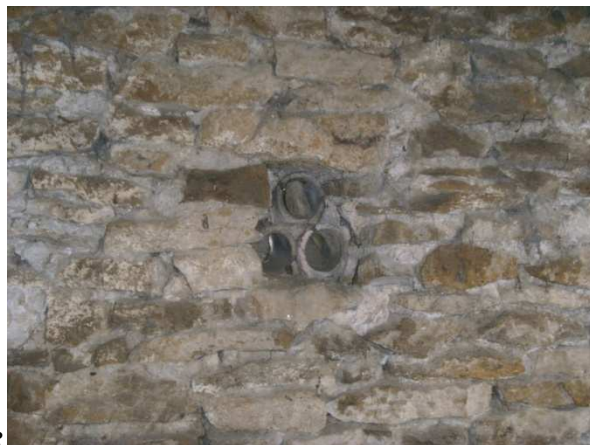
*Land-drain ventilation detail, cow byre*

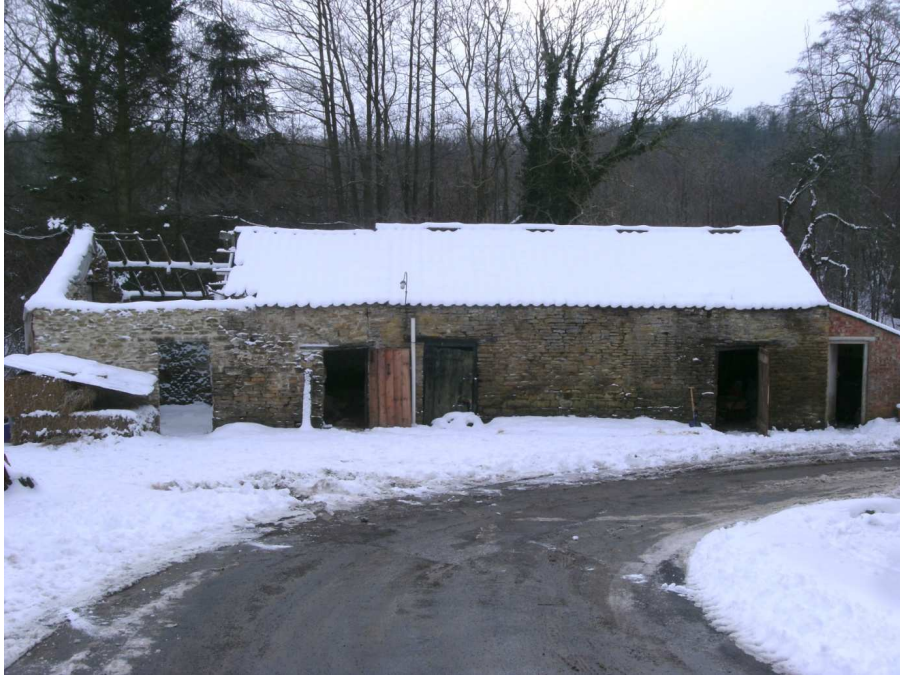
*W wall of cow-shed*

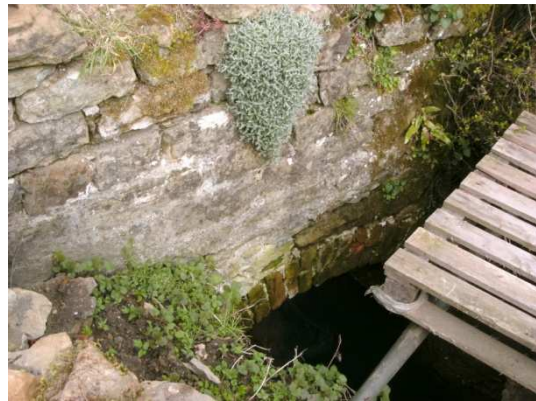
*beginning of the 'myll bridge' under the road. This is of some age, and existed when the beck was forded and at least as early as 1604 when Davyll was fined for not maintaining the flow of water beneath it*

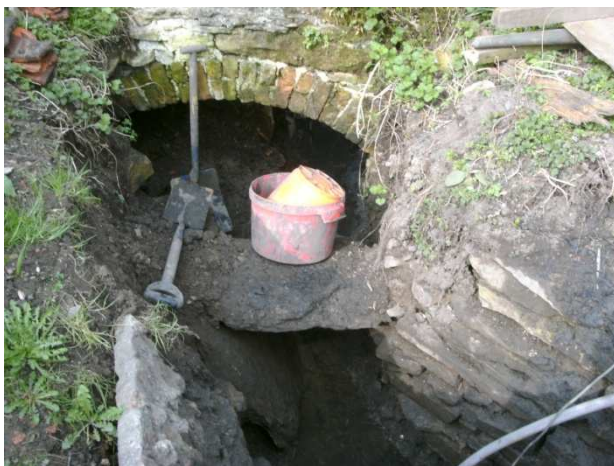
*to the roadside of the arch, flat slabs of local cornbrash which formed a 'bridge' and the level of which probably indicate an earlier ground level.*

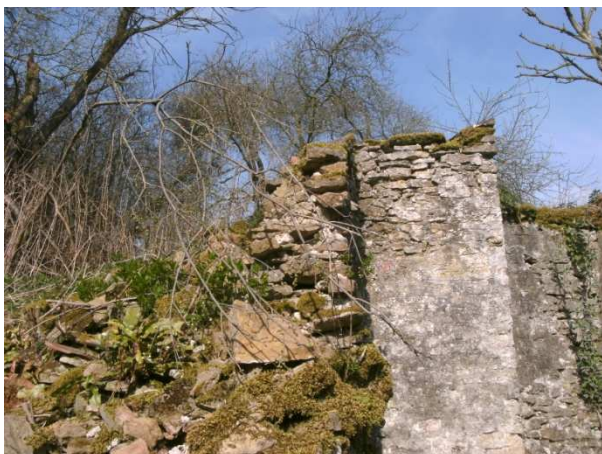
*part of the mill dam. The buttress of this is battered, not leaning; the retaining wall of the tail-race is at left and returned along the line of the back wall of the pig-sheds and forge, they being part of the same retaining wall.*

The retaining wall behind the mill-wheel and which holds the penstock is somewhat deflected, but this is of no structural concern. Its masonry is bound with lime mortar. Approximately half a metre square is loose at low level and needs to be removed and re-bedded. Five stones are missing at high level and require reinstatement. Approx. 50% of the wall requires re pointing and deep-packing with lime mortar.

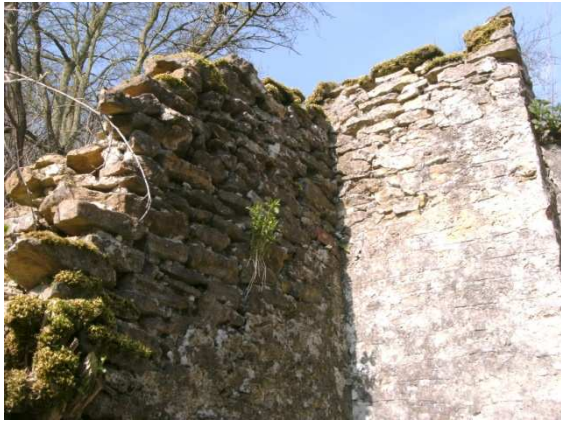
*junction of mill-dam and forge walls (below),  
the former returning S as part of the rear wall  
the pig sties (left).*

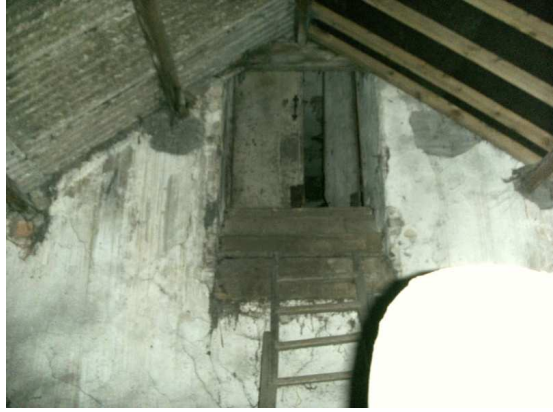
*door into attic of house from within millhouse*

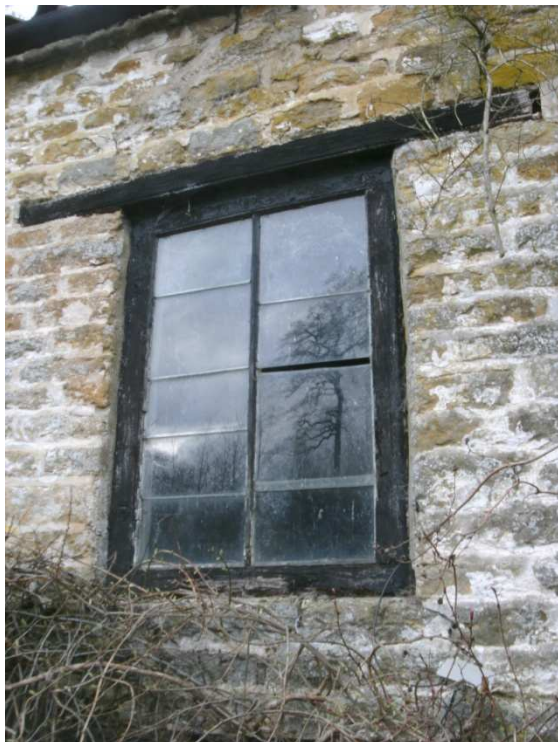
*window, with lapped panes of glass*

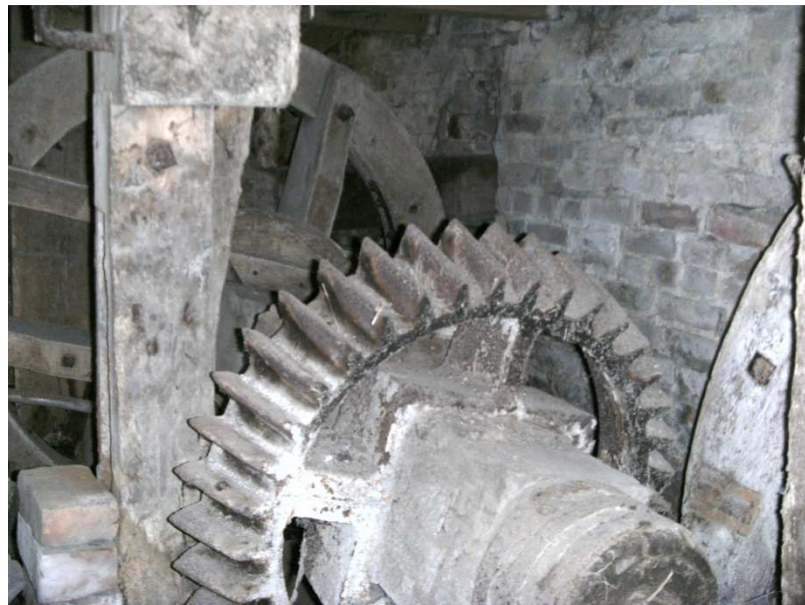
*within- note the liberal use of coach-bolts, which may be interpreted as having been introduced during 20thC repairs.*

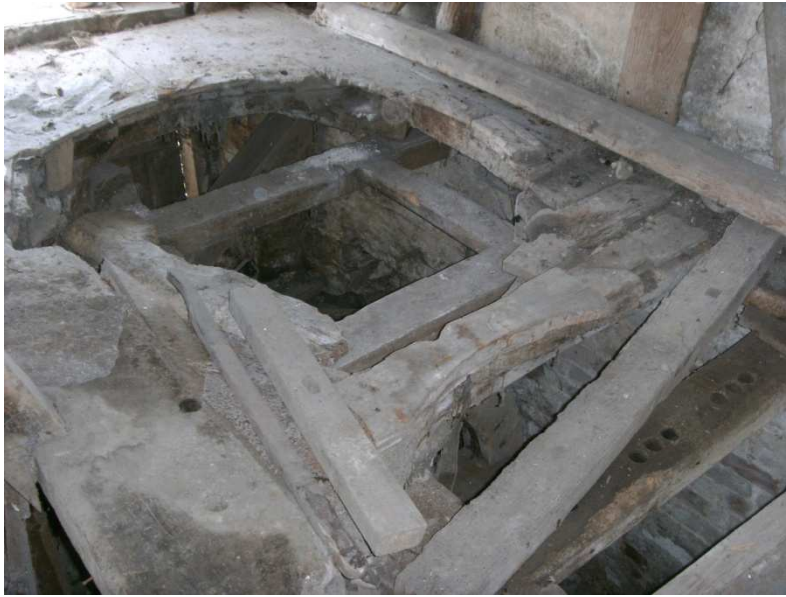
millstone seat
